**Federal Aviation
Administration**

ADVISORY CIRCULAR 43-16A

AVIATION MAINTENANCE ALERTS

ALERT
NUMBER
276

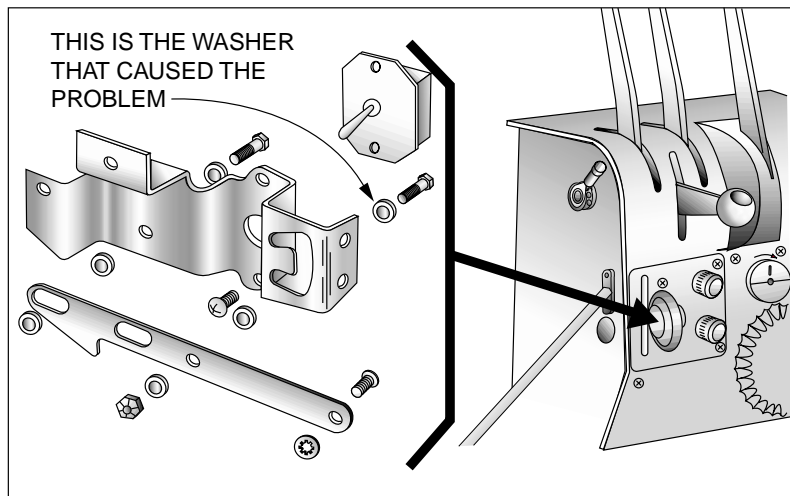
The pilot reported that during takeoff, with the airspeed at 70 knots, the landing gear retracted without command. There were no personal injuries; however, there was damage to the aircraft requiring an aircraft incident report.

During an investigation, a technician discovered that when the gear selector handle (P/N 644-183864) was moved to the "down-and-locked" position, it did not always fully engage in the detent. (Refer to the illustration.) He disassembled the pedestal and discovered a small washer was getting caught in the detent groove. When the washer got caught in the detent groove, the gear handle stopped on the edge of the detent. Even slight hand pressure provided enough impetus for the gear handle to "pop" upward into the "gear-up" position.

The landing gear selector handle is not normally removed during scheduled inspections; however, a gear retraction test is required. The submitter suggested maintenance technicians use this opportunity to ensure the handle goes completely into the "down-and-locked" detent each time the gear is placed in the "down" position. In this case, the gear handle caught approximately once every seven cycles.

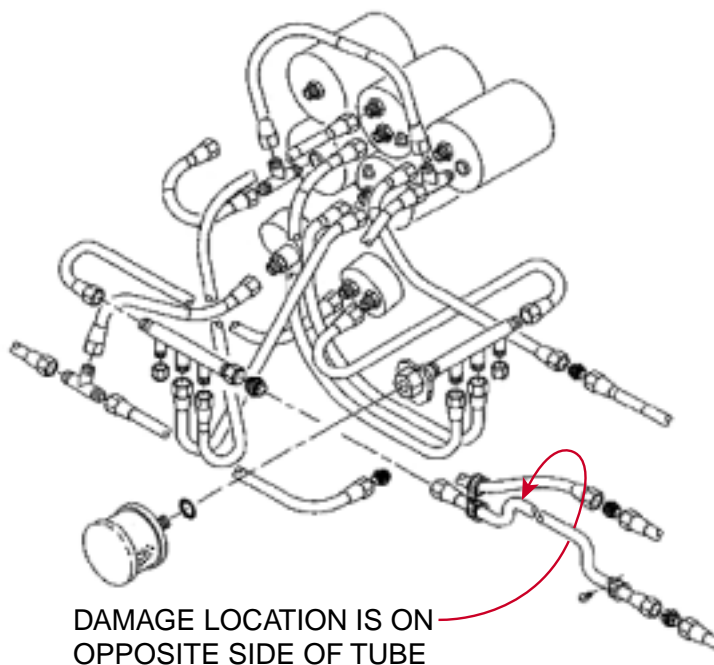
A technician investigated the problem and found an aluminum line (P/N 101-320266-1) was chafing against the radar unit installed in the instrument panel. The chafing action had penetrated the line wall thickness causing it to leak. He speculated this problem might be responsible for pressurization problems. (Refer to the illustration.)

The submitter did not find support clamps at the center of the line. He suspects vibration caused the line to wear against the radar unit. He suggested inspecting like aircraft for proper clearance and support for the line.

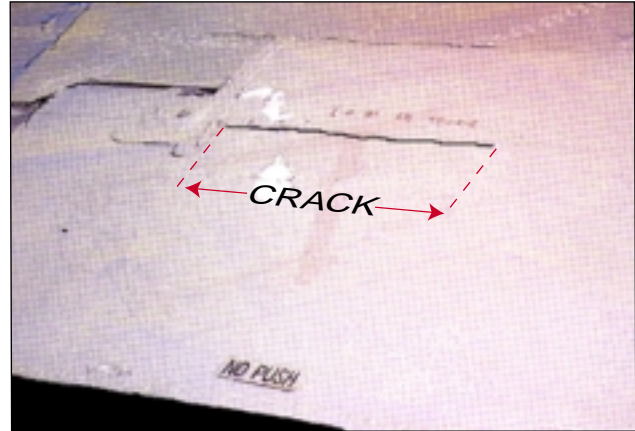
During a scheduled inspection, the technician discovered a 6-inch crack in the right aileron skin.

The top aileron (P/N 99-130000-617) was very close to complete failure and separation from the aircraft. (Refer to the illustration.)

The aircraft manufacturer issued Service Bulletin (SB) 57-3148, dated January 2001. The SB deals with this subject and makes a repair kit (P/N 109-4011-1) available. The kit includes an improved replacement skin which is designed to prevent this type of failure.

The technician obtained and installed the replacement skin kit. He suggested that the FAA consider using this report as the subject of an Airworthiness Directive.

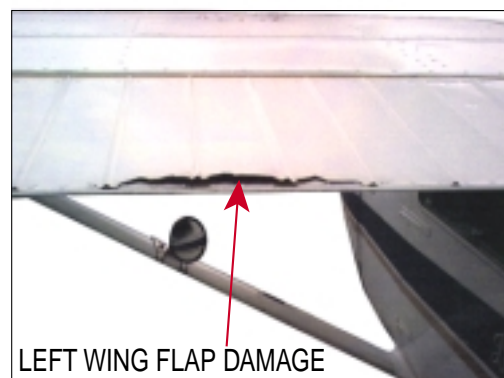
During a postflight inspection, a technician found a long tear in the left wing flap (P/N 0523901-33) skin.

The upper flap skin was broken a distance of approximately 10.25 inches at the trailing edge. Also the upper and lower flap skins were cracked around several of the trailing edge fasteners outside the broken section. (Refer to the illustration.)

Although the exact cause of the damage could not be determined, the submitter speculated the wing flaps were deployed at excessive airspeeds. Also, the aircraft was being used for glider towing operations on the flight prior to the discovery of this damage.

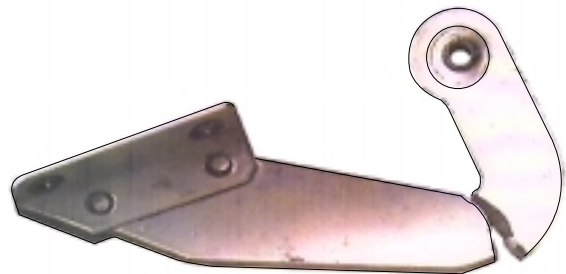
During a postflight inspection, a technician discovered a main landing gear hinge was broken.

The forward left main landing gear outboard door hinge fitting (P/N 42059-07) had failed. (Refer to the illustration.) The technician removed the door and found the rear hinge fitting was cracked in the same area where the forward hinge failed. This finding led the technician to inspect the same door on the right main gear where he also found cracks.

The submitter stated he has found this type of defect on several like aircraft. He recommended giving special attention to the main gear door hinges during inspections. He warned that even a slight paint separation might indicate an underlying crack.

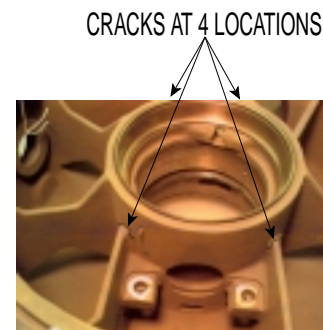
During a scheduled inspection and maintenance, a technician discovered the transmission case was cracked.

The lower transmission case (P/N 206-040-150-029) was cracked at four locations adjacent to the support webs. (Refer to the illustration.)

The submitter did not give a cause for this defect or any further details. It is possible the case cracks were caused by metal fatigue resulting from a high number of operating hours.

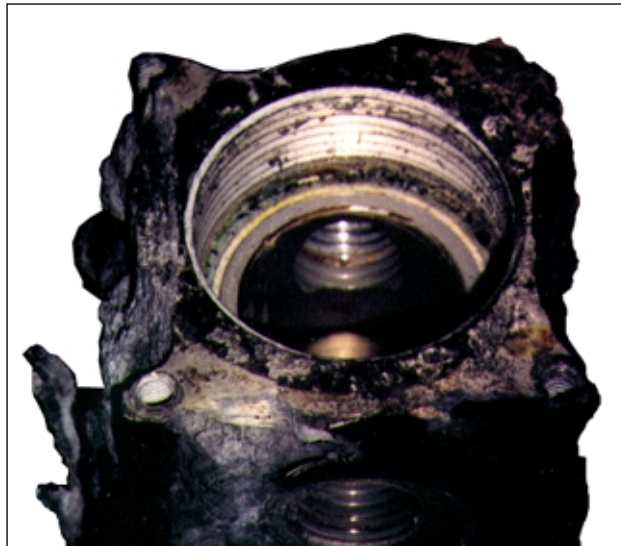
The fuel distribution block is machined from aluminum and is used to route fuel from the blast valve to the pilot light, crossover, and coils. The block is secured by four threaded holes in the corners of the assembly. The erosion of the aluminum material had progressed to the point that one of the fastener holes was missing. (Refer to the illustration.)

The submitter could not determine the cause of the damage; however, for corrosion to progress to this state, would require either a long period of time without detection or exposure to a corrosive material.
